MARINE PILING INVESTIGATIONS

NATIONAL RESEARCH COUNCIL

MARINE STRUCTURES

THEIR DETERIORATION AND PRESERVATION

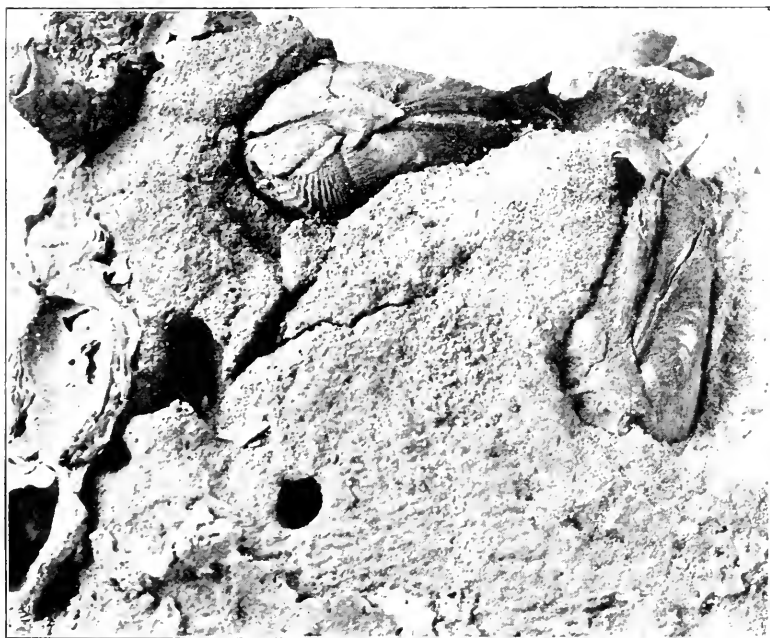
"The species occasioning most of the damage was found to be *Pholadidea penita* Conrad, known commonly as the "rock clam." (Fig. 18.) It occurred from two feet above mean low water to one foot below, which was the lowest level at which we were able to work. It doubtless similarly occurs on down to the mud, even in deep water, as it has been dredged in San Francisco Bay at a depth of fifty fathoms.

"As regards extent of the damage occasioned by borers in concrete, a review of the data assembled by Mr. Hughes, Mr. Ludlow, Mr. Sadler and Dr. Miller, indicates that, of concrete jacketed piles at four different locations in Los Angeles Harbor, in fact at every point in the inner harbor where such piles exist, about 50 per cent have been more or less attacked, of which rather more than one-fifth have been very considerably bored. Of those not attacked, a number stood so well inshore as to be but little exposed to the action of the borers. If all such piles were eliminated from the count, the percentage of jackets damaged would be considerably higher.

FIG. 18—PHOLADS IN CONCRETE CASINGS AT LOS ANGELES, CAL.

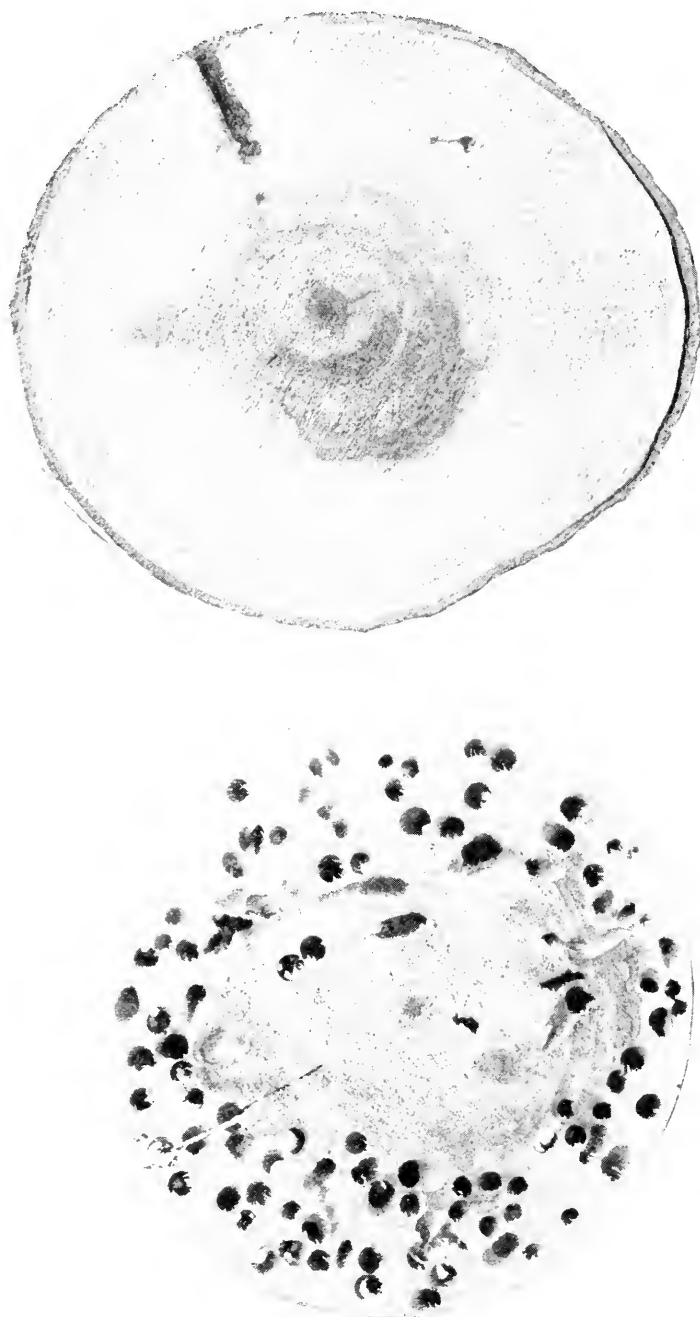
FIG. 20—SECTIONS OF BARKED AND UNBARKED COTTONWOOD TEST PIECES IMMersed AT PIER 1, NORTHERN PACIFIC RY., SEATTLE, SEPTEMBER 27, 1923 AND REMOVED JANUARY 28, 1924

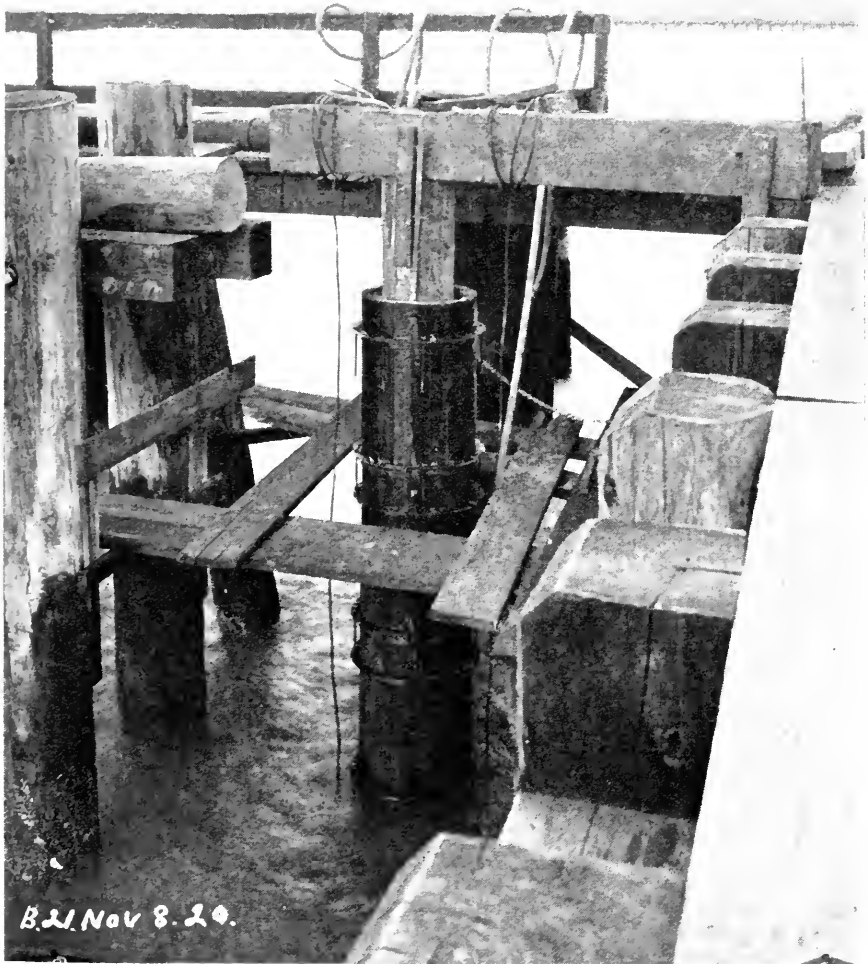
FIG. 24—FORMS IN PLACE FOR CONCRETE CASINGS CAST IN PLACE. "CAMP SYSTEM."

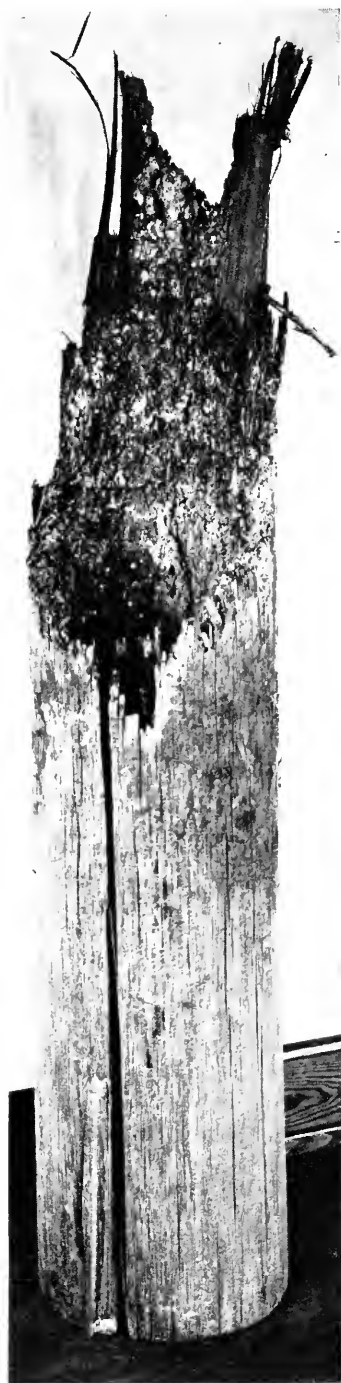
Specimen No. 4—From Pensacola Naval Station, Pensacola, Fla. Pine pile driven in 1902. (Fig. 26.) Specifications required absorption of 20 pounds of creosote per cubic foot. One hundred and ninety-eight piles in structure. In 1906 five piles were so badly damaged as to require renewal, and entire structure is now unsafe. Destruction was caused mainly by *Bankia* and *Limnoria*.

FIG. 26—SECTION OF PILE FROM I ENSACOLA NAVY YARD SHOWING WORK OF MARINE BORERS.

One hundred and ninety-eight of these piles treated with 20 lb. per cu. ft. creosote were driven in 1902. At the end of three years five were badly attacked, necessitating the removal of two. Report of September, 1922, states that "all of the piles driven in the work are in such condition that quite a few have been broken off at about approximately water level by wave action. A large majority of the remainder can be broken off at the same level without much difficulty."

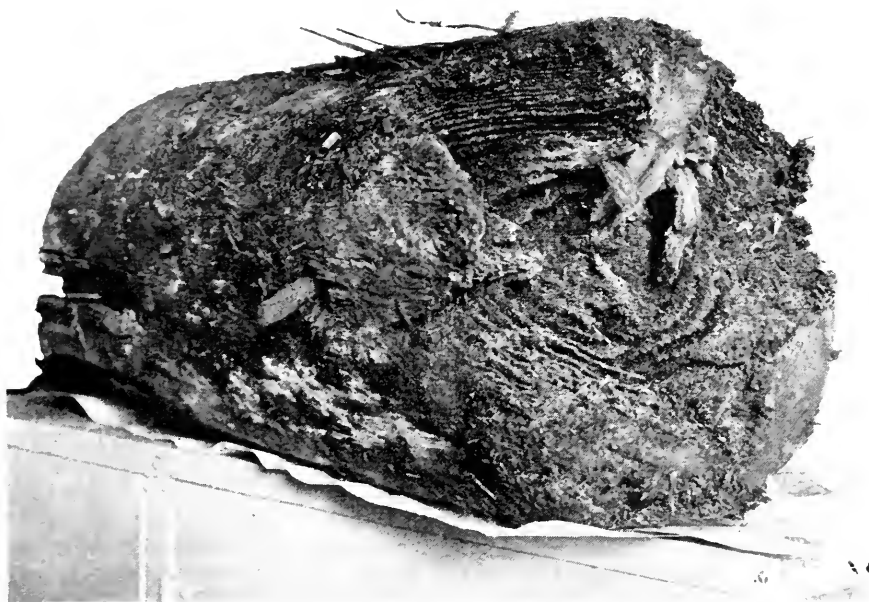
Specimen No. 8—From Lighthouse Pier at San Juan, Porto Rico. No record of treatment available. (Fig. 28). It had 8 years' service and was destroyed by *Limnoria*. It was cut up for other species and none were found.

FIG. 28.—SECTION OF CREOSOTED PILE FROM LIGHTHOUSE WHARF, SAN JUAN, PORTO RICO, TAKEN FROM LOW WATER LINE.
Built, 1898—Renewed, 1906

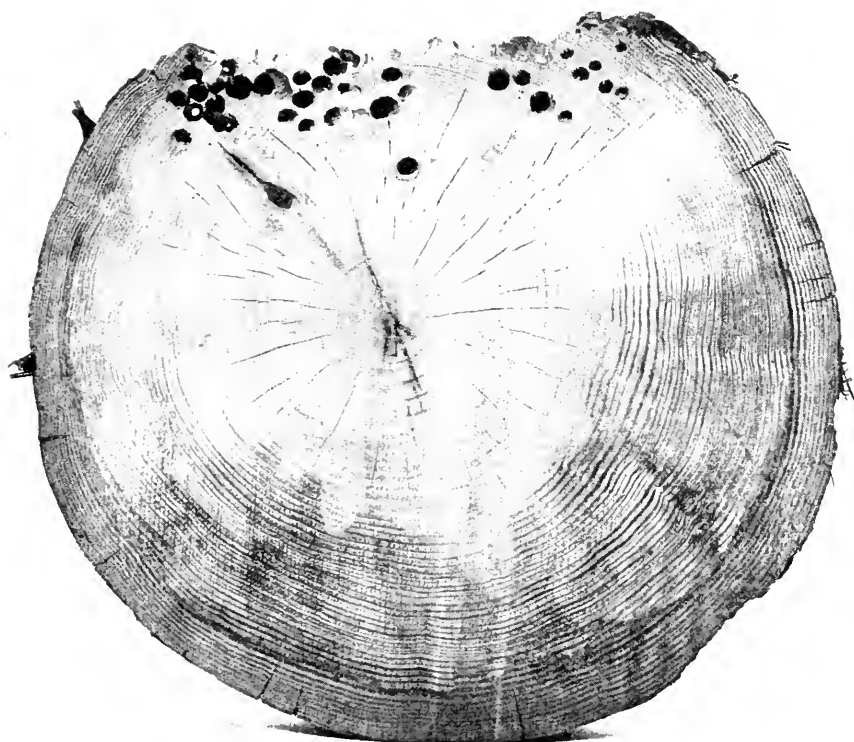
Specimen No. 9—Section of pine pile from foundation of 150-ton revolving crane at the plant of the Newport News Shipbuilding Company. (Fig. 29). These piles were treated by the Norfolk Creosoting Company in 1897 with a 16-pound treatment. The creosote was purchased under the following specification:

On account of the importance of this foundation it has been inspected frequently and carefully. Shipworm attack first appeared about 1920, or after 23 years' service, and the pile analyzed was removed in 1922, after 25 years' service.

FIG. 29—PILE SECTION WITH 16 LB. CREOSOTE TREATMENT. 25 YEARS' SERVICE IN 150 TON CRANE FOUNDATION, NEWPORT NEWS SHIPBUILDING & DRY DOCK CO., NEWPORT NEWS, VA.

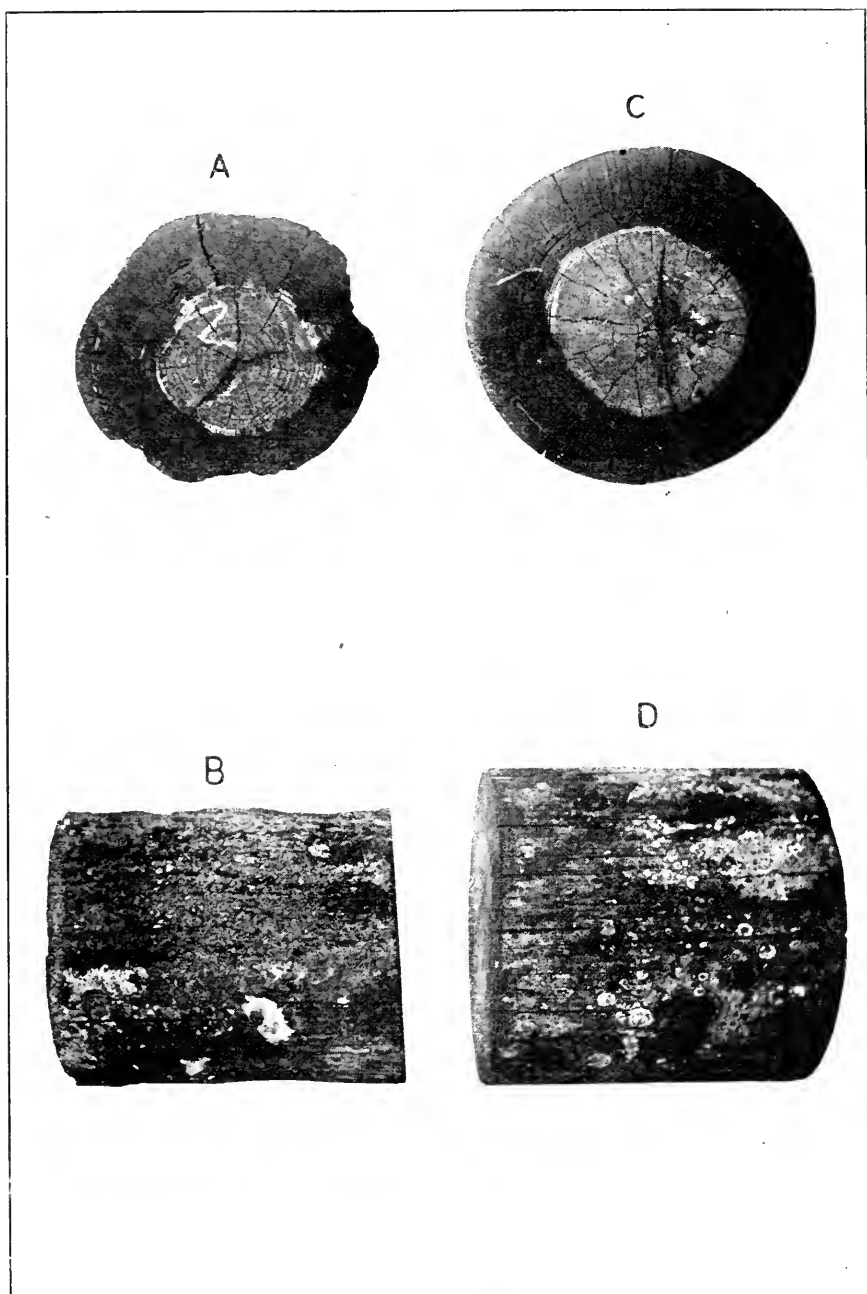
FIG. 21—PILE SECTIONS FROM TURTLE RIVER DOCKS, SOUTHERN RY.,
BRUNSWICK, GA.

A. B.—Pile driven in 1913
C. D.—Pile driven in 1909

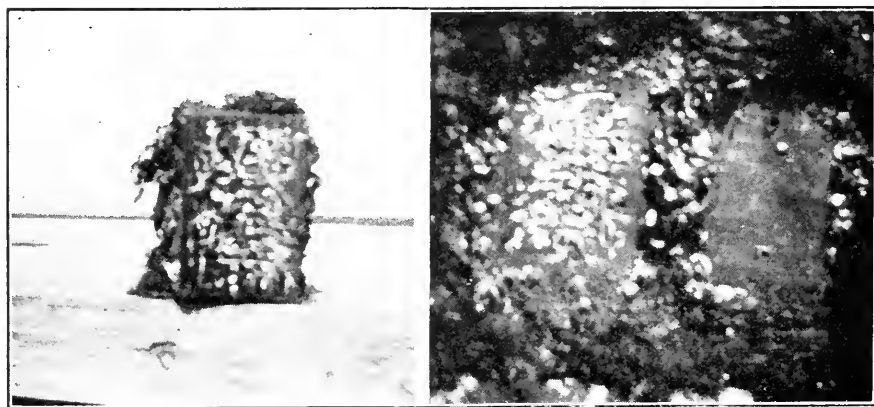
The accompanying small photographs demonstrate that the shipworm will cross a crack. (Fig. 32). The block (left) was removed from the base board (right) after three months' exposure. The face of the block in the picture shows distinctly that the borers passed through the base board into the block. It was observed at the Bureau of Fisheries Laboratory that shipworms frequently crossed gaps of at least 1/16-inch from one piece of wood to another, which fact shows the fallacy of the old belief that the *Teredo* will not cross a crack.

FIG. 32—SHOWING THAT SHIPWORMS WILL CROSS A CRACK

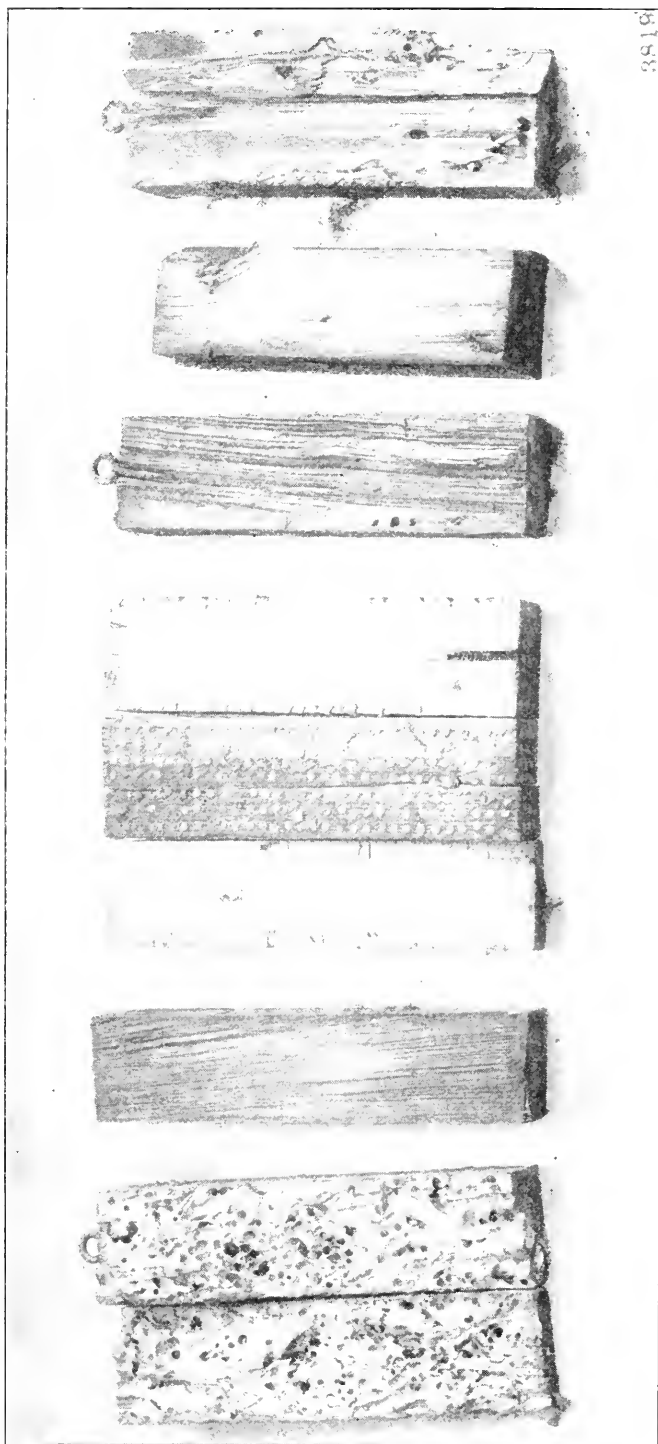
FIG. 35—DETAILS OF SECTIONS OF TEST PIECES AFTER EXPOSURE (ONE-FIFTH ACTUAL SIZE)

- 1—Blank—no impregnant used.
- 2—Creosote impregnation.
- 3—Aczol impregnation.
- 4—Copper studded pieces.
- 5—Crystal violet.
- 6—Sulphur impregnation.

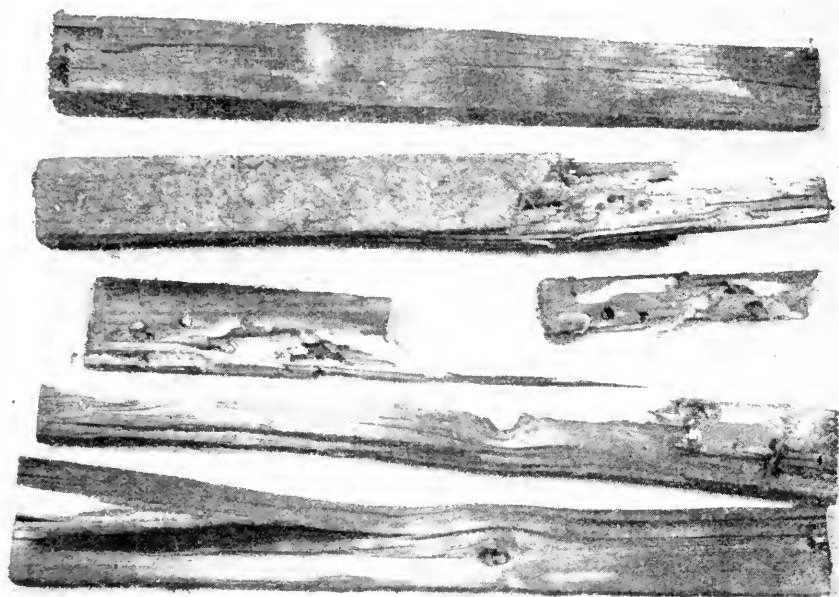
FIG. 36—DETAIL OF ATTACK ON CREOSOTED TEST PIECE

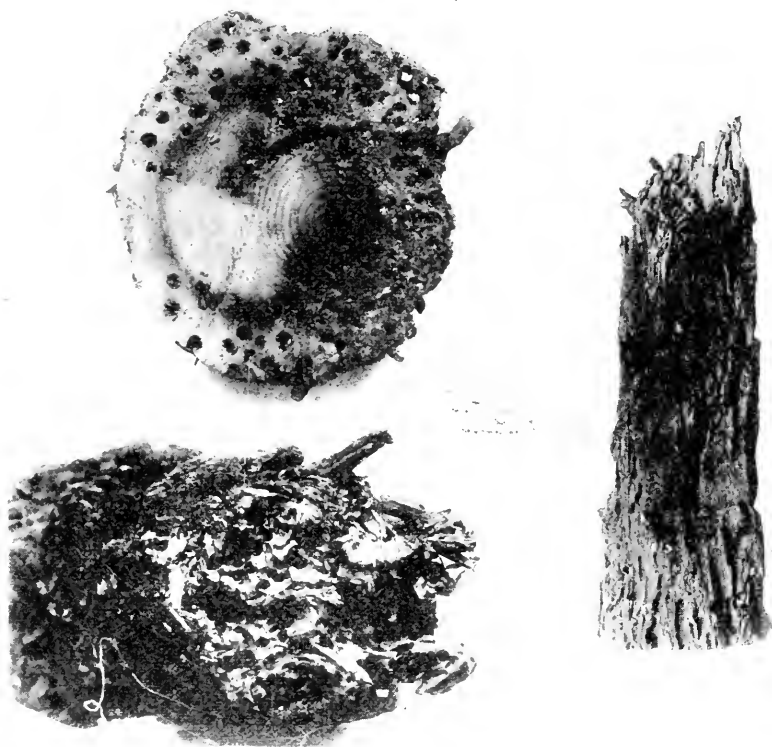
Pier 6, Standard Oil Company, Bayonne—Live specimens of *Teredo* were not found, but the borings were recent and some of the piles were practically destroyed by *Limnoria* and *Teredo* in five years, (Fig. 66).

FIG. 66—SECTION FROM A PILE DRIVEN IN STANDARD OIL PIER No. 6, BAYONNE, N. J., IN 1915 AND REMOVED IN 1922.

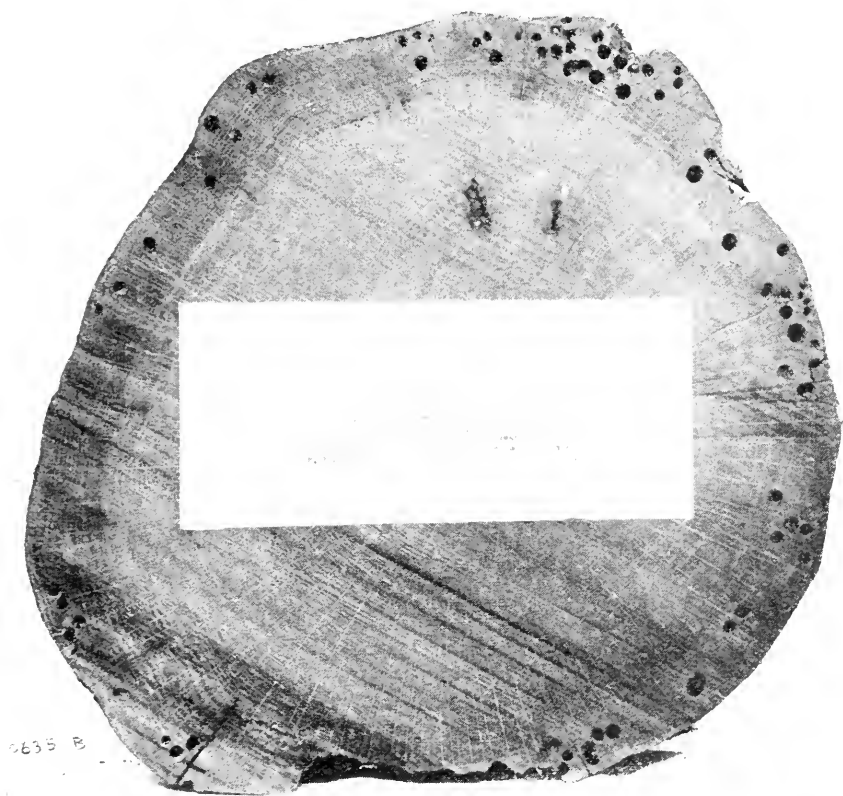
FIG. 67.—SECTION OF PILE FROM LEHIGH VALLEY RAILROAD PIER A, JERSEY CITY
FROM WHICH LIVE *Teredo Navalis* WERE EXTRACTED

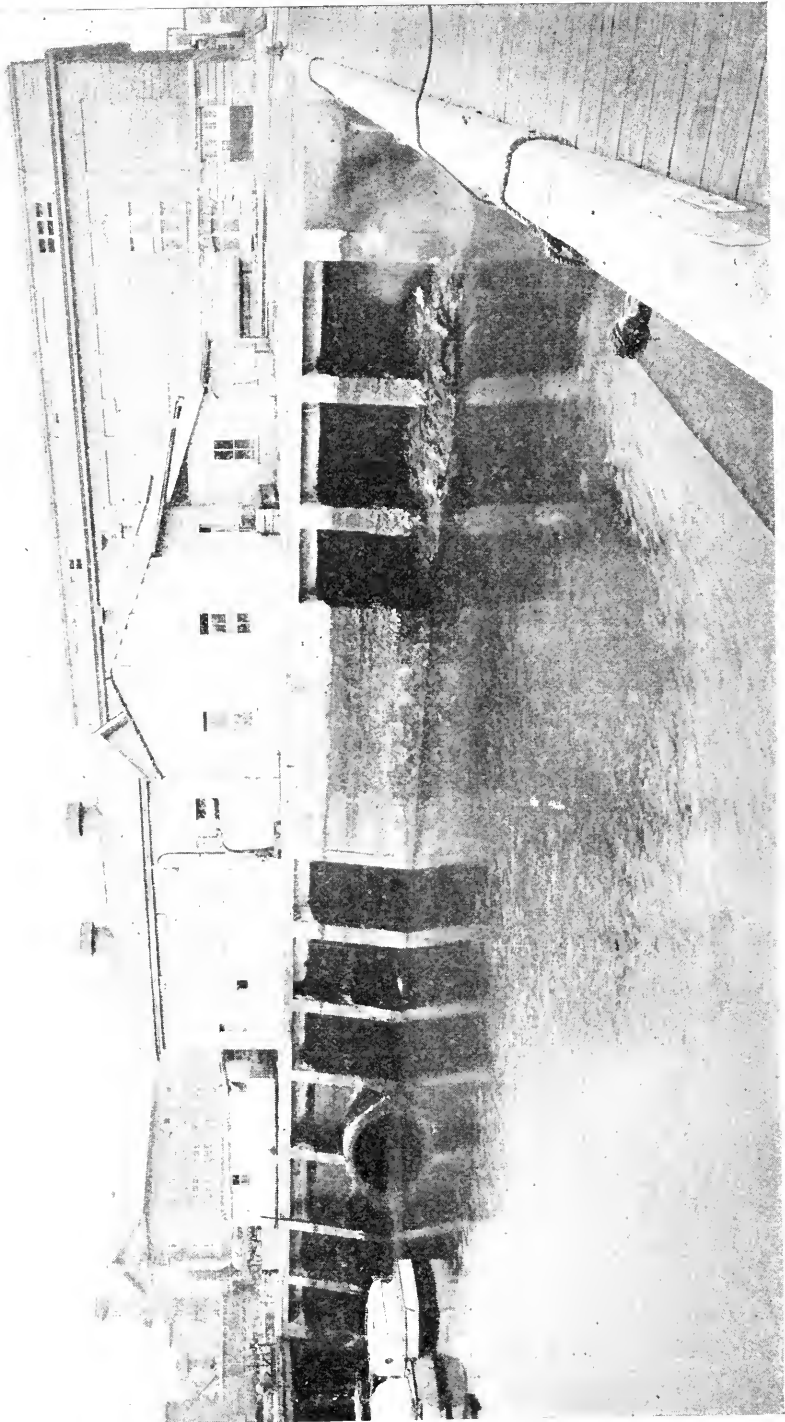
The mixture was 1:3:6 with a 1:2 mortar facing. The lower 6 feet of the wall was placed in the dry, but the tide frequently covered the remainder, which was carefully cleaned and grouted before recommencing work. The wall has been repaired at various times, and in March, 1923, showed considerable deterioration.

FIG. 141—SEAWALL SECTION, PUGET SOUND NAVY YARD, SHOWING CONCRETE DISINTEGRATION

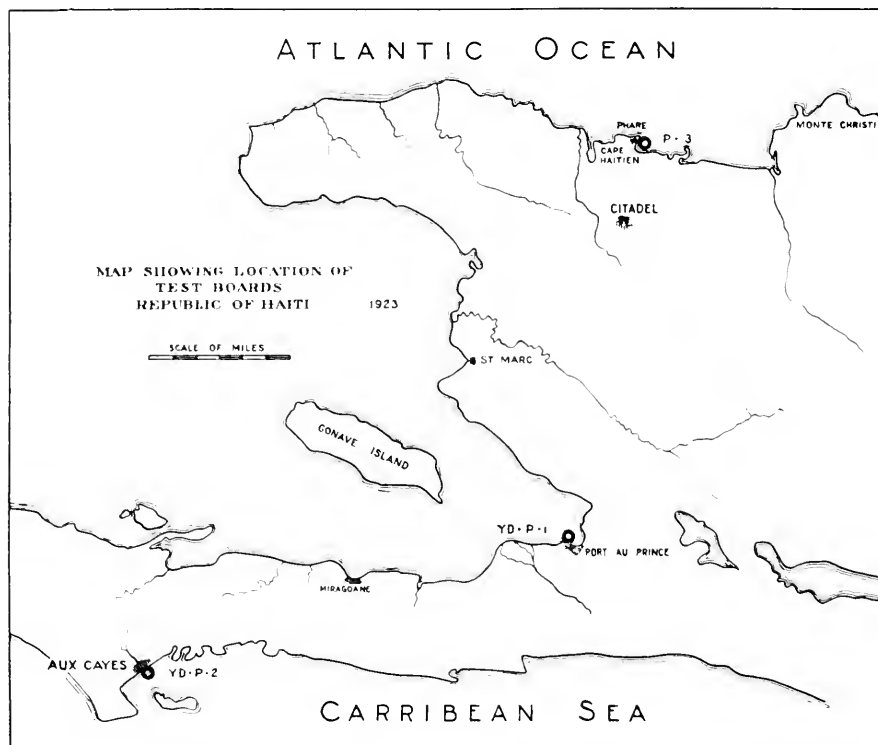
FIG. 157

Committee Investigations—Standard test boards were installed as follows (Fig. 157):

YD-P-1—Many shipworm punctures were visible on block 1, removed December 15. Block 2 contained about 200 embryonic shipworms, and block 3, removed January 15, about 100 specimens of *Teredo portoricensis* and *Teredo sp. G*, the largest animal having attained a length of 30 mm. Block 4, removed February 1, was well filled with *Bankia sp. V*, *Teredo sp. E*, *Teredo portoricensis* and *Teredo sp. G*, the two last named having tubes of 30 mm. in length and containing larvæ. In block 5 the greatest length recorded was 3 inches; *Bankia sp. X* and *Teredo clappi* also appeared in this block. Succeeding blocks were well filled, the majority of specimens being *Teredo sp. G*, except in block 10. Block 10 contained *Teredo sp. W*. A new board of the 1923 model was substituted for the old, June 1. The

new blocks were attacked with about the same degree of intensity as the old, the numerical supremacy shifting from *Teredo sp. G* to *Teredo clappi* and again to *Teredo sp. G*. *Teredo johnsoni*, *Teredo somersi* and *Teredo fulleri* were added to the list of new species. The largest specimen of *Teredo* found was 100 mm. in length, representing a growth of not more than 2 months; the largest of *Bankia* was 125 mm. in length, the age of the specimen not exceeding 4 months. *Limnoria* action was severe. Associated organisms were *Balanus* and Bryozoa.

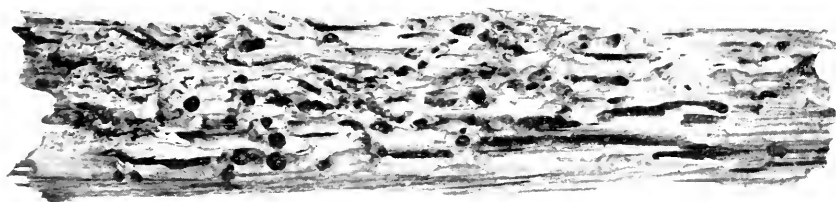
FIG. 169—SECTION FROM COVER PLATES OF PASSAIC OUTLET SEWER NEAR
ROBBINS REEF LIGHT, NEW YORK HARBOR

The section shown in the illustration (Fig. 169) is from the plank joining the cover plates and was removed May 31, 1924.
